# TROUBLESHOOTING YOUR RIFLE and SHOTGUN

By J. B. Wood

**Do-it-Yourself  
Diagnosis and Repair  
for Rifles and Shotguns**

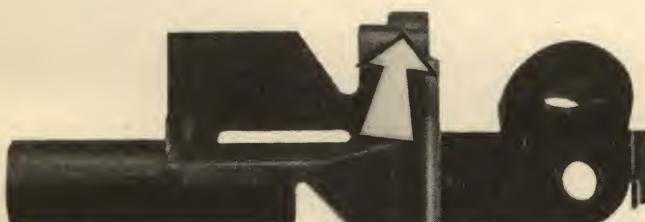
The cartridge guide is made of formed sheet steel, and the ejector (arrow) is integral with the guide. If the ejector wears, or breaks off, the entire guide must be replaced.

I have occasionally seen breakage of the ejector, a simple projection from the left feed lip of the cartridge guide. When this occurs, the only cure is replacement of the cartridge guide, as this is a part formed of sheet steel, and there is no feasible way to repair it.

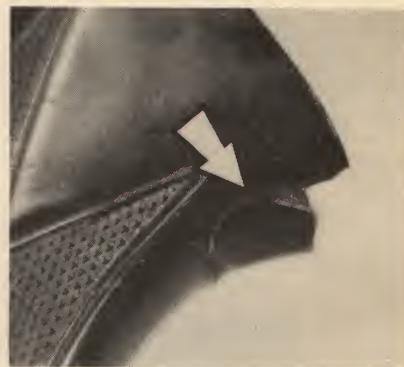
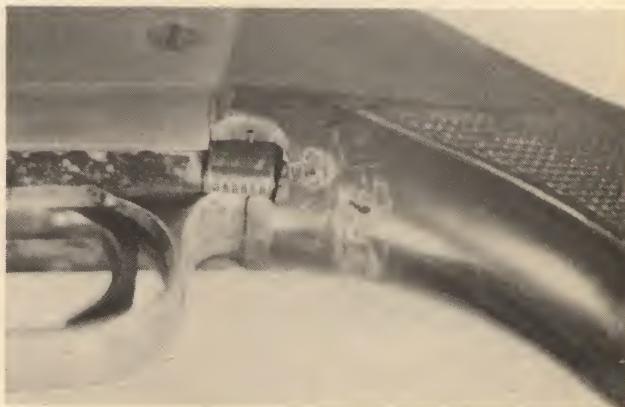
The Stevens Model 1244 features a plastic (Tenite) stock that's subject to breakage. The arrow (top photo) indicates a typical break. In the photo on the right the break in the stock has been "welded" inside and out through the use of a soldering iron—a rough, but effective repair.

a stove, or leave it in the window-rack of your truck in the Texas sun. On shotguns, though, especially in the heavier gauges, the Tenite proved less than satisfactory, to put it mildly. This was an early plastic and lacked the stability of today's materials of this type. Just as extreme heat softened it, very cold temperatures tended to make it brittle, and the pounding of 12-gauge recoil (the only chambering offered in the 1244) was often too much for it.

The stock would usually begin to crack just to the rear of the trigger guard, at the point where the lower edge meets the receiver, and no glue known to man will stick to Tenite plastic. For several of the Tenite-stocked guns, Savage/Stevens can supply a replacement stock of wood with a different mounting bolt. With the 1244, though, you are out of luck, as this one has been obsolete for so long that no parts, including stocks, are available. I recently repaired a broken Tenite stock on a 1244 by "welding" the crack with the tip of a soldering iron, inside and out, and this seems to be a serviceable, though unattractive, method. It held together for several heavy test loads, but I have no doubt that it will break again, eventually.

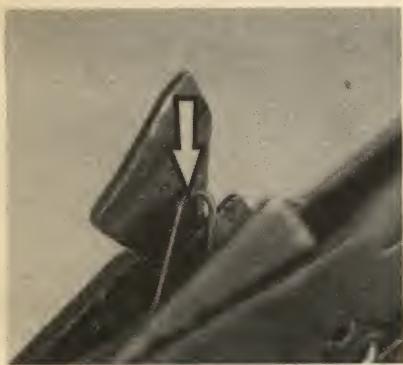
One of the 1244's more critical parts is the bolt handle latch release spring (arrow)—check it for deformation or breakage.

share some of the same ailments. There is a stud on the left side of the hammer which contacts a hook-shaped spring on the bolt lock, drawing the lock down and out of engagement as the hammer falls. This spring is subject to both breakage and deformation, and replacing it is not a fun project. It will have to be made, and its shape and length must be exactly right for proper operation.

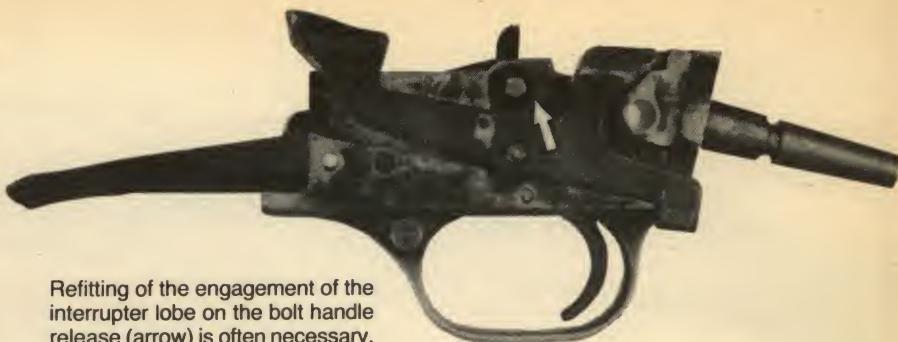
Refitting of the engagement of the interrupter lobe on the bolt handle release (arrow) is often necessary.

There is an interrupter lobe on the bolt handle latch which contacts a large stud on the upper left side of the hammer, preventing the hammer from dropping before the bolt is locked in place. With extreme wear, or amateur alteration of the sear or sear step on the hammer, this lobe can make improper contact and make operation of the manual bolt release difficult, if not impossible. In this case, any good gunsmith can alter the mating of the lobe with the stud on the hammer and can correct the problem without replacement of parts—if, indeed, any parts could be found. Considering the problems, if you own one of these guns in good condition, it might be best to just put it away for the future time when such a limited-production Stevens gun might have some collector value.

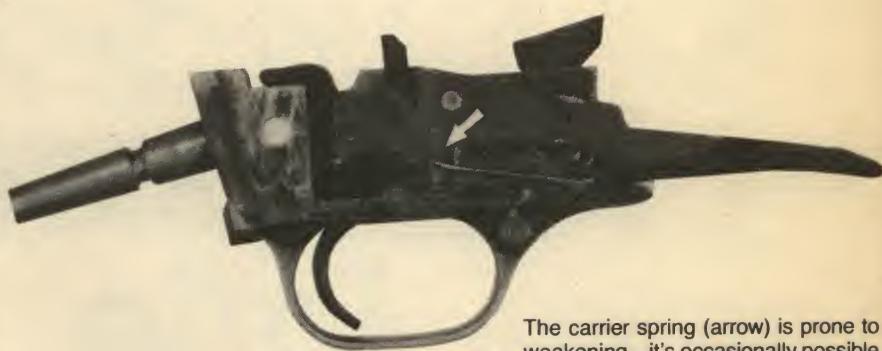
The carrier spring (arrow) is prone to weakening—it's occasionally possible to reshape it without replacing the entire part.

Also a round-wire type, the carrier spring is located on the right side of the trigger group and looks deceptively simple. This one rarely breaks but is prone to weakening. Here, again, the length of the spring and its engagement with the lobe on the carrier are quite critical. There is one bright note here—the carrier spring for the slide-action Model 77 series gun—still available—will usually interchange.

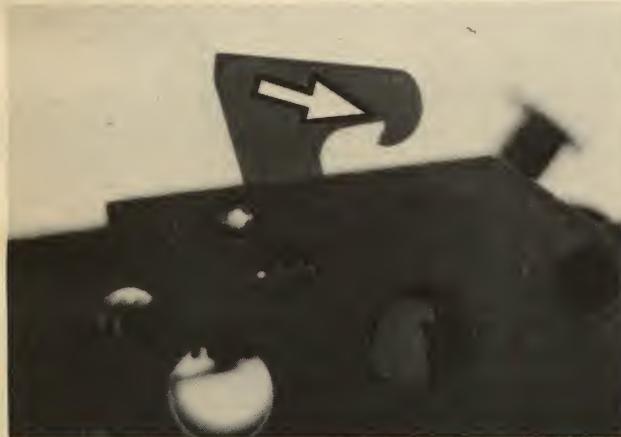
The sear beak of the hammer is at the top rear (arrow) giving good leverage and a crisp trigger pull. A sear system of this type is not tolerant of amateur alteration.

The sear contact beak of the hammer is at the top rear of that part, giving good leverage which contributes to a crisp trigger pull. It should be noted that a sear system of this type is not tolerant of amateur alteration. The factory pull is excellent, though, and I doubt that many will try to change it. The safety catch is conveniently located on the upper tang, just to the rear of the receiver and is pushed forward to off-safe position.

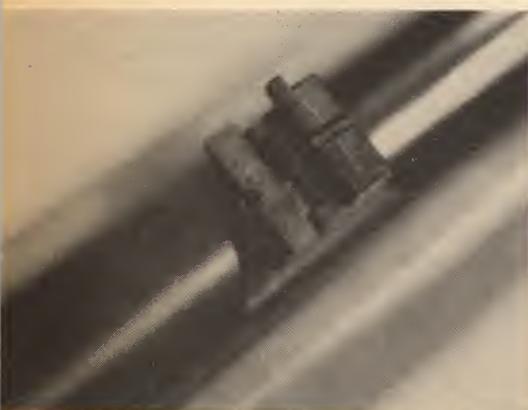
to damage, and it has nothing to do with the feed or firing mechanisms. The Mark XXII is fitted with a rear sight that is similar in principle to the ones used on some of the older British sporting rifles. It has a fixed base with a notch for closer range shooting, and two pivoting leaves marked for the longer ranges. The pivot loops of the two leaves are each offset, to utilize the same cross-pin, and this results in the rear leaf having a long projection to the left, and the front leaf a similar extension to the right. If either of these unsupported projections suffered a blow of sufficient force, they could be deformed or broken off. If only deformed (and this might not be noticed), accuracy might be affected. This is no great detraction, though, as the receiver has provision for mounting a scope sight, and these days, nine times out of ten, a scope is used rather than iron sights.

While the two-leaf folding rear sight is an ingenious design, it's susceptible to deformation or breakage if struck sharply.

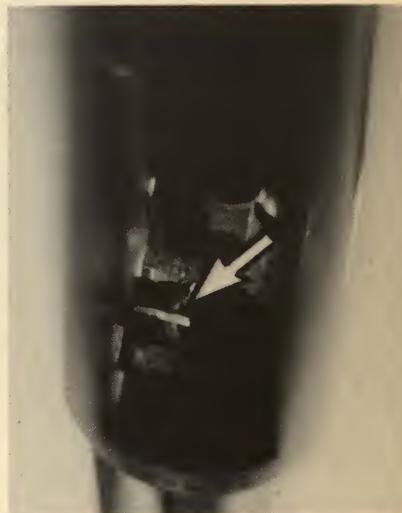
All of the springs in this gun are round-wire type, either helical coil or torsion, according to function, and there is ample allowance for age weakening. The only part which occasionally causes trouble is the cartridge cutoff, located in a cylindrical housing at the rear mouth of the magazine.

The cutoff is a simple, flat part, pivot-mounted with a single pin, and has two lobes at the rear. One lobe contacts the cartridge rim, to keep the round in the magazine until the action is cycled. The other lobe bears on the action slide bar, and a shoulder on the bar cams the cutoff inward as the action bar is moved, preventing the feeding of more than one round each time. The cartridge contact lobe, which touches only the brass of the cases, is not subject to much wear. The other, however, is eventually worn to some degree by the action bar; and, when this wear is severe enough, the inner lobe will have insufficient protrusion to properly stop the cartridges. Replacement of the cutoff is the obvious cure for this problem; and, although this is an obsolete model, many gun shops still have parts on hand, and some may still be available from the factory. If not, the cutoff is not difficult to make. Installation, however, is somewhat more than a routine job and should be done by a gunsmith.

In this view through the bottom of the receiver, the arrow indicates the cartridge cutoff, the one part in the Model 61 most likely to cause difficulty.

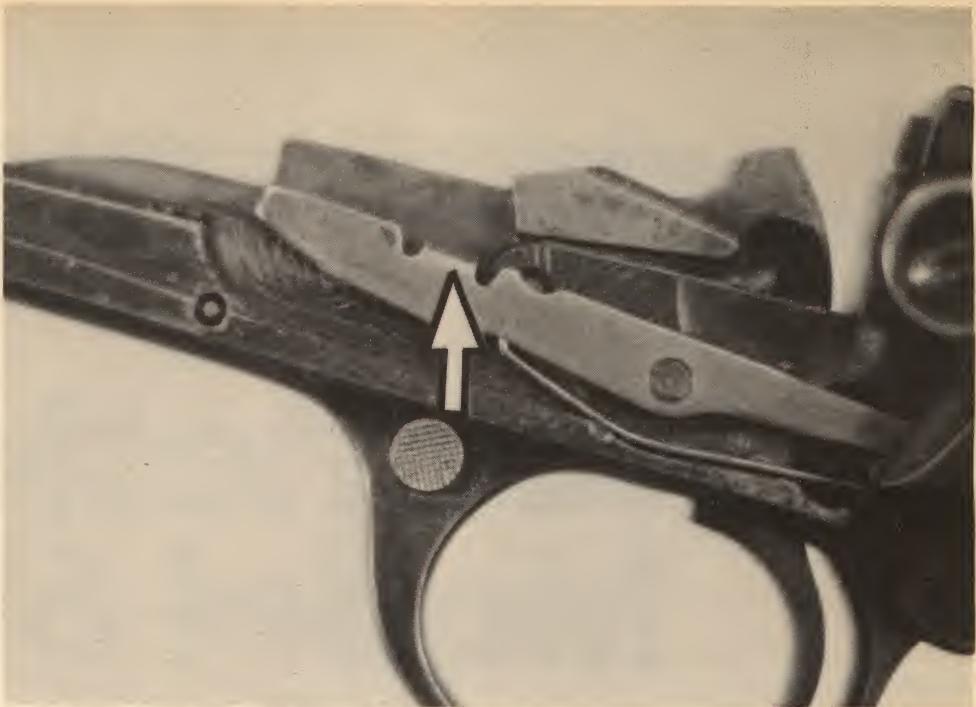
In this view, the arrow points to the turned-over shelf on the slide lock, which is the contact point for the left lug of the hammer. Here the hammer is cocked, the slide lock is elevated.

The arrow indicates the engagement of the left lug of the hammer with the slide lock. In this view, the hammer is down, the slide lock depressed.

turned-over shelf at its forward end that is struck by a lug on the left side of the hammer each time the hammer falls, to unlock the action. I have seen one case in which the shelf broke away from the slide lock, and since the factory no longer has this part, it was repaired by welding.

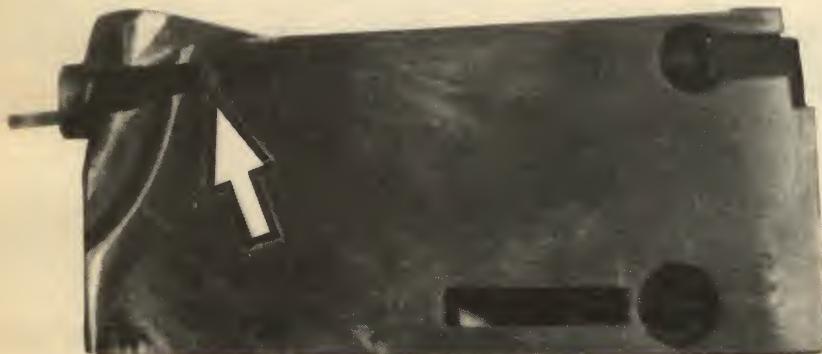
On the right side of the breech block (bolt), the arrow points to the firing pin stop pin, which not only retains the firing pin but also compresses the firing pin return spring.

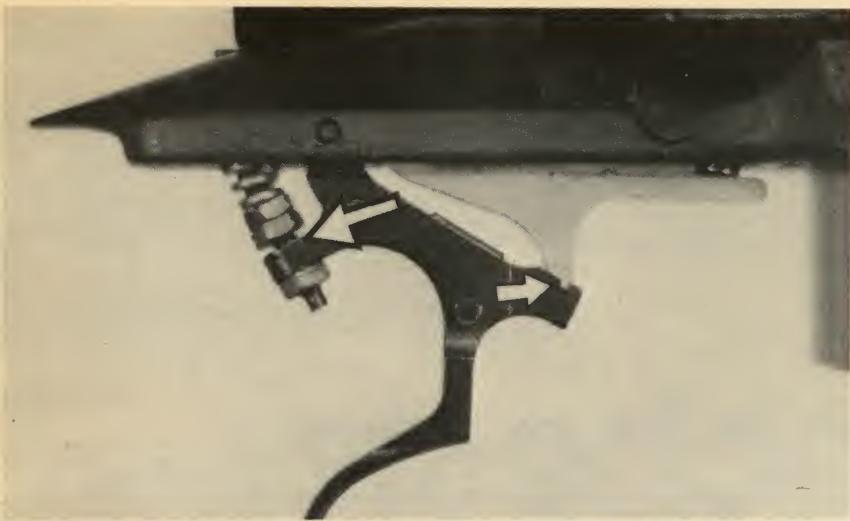
Trigger spring tension and over-travel are adjustable by means of three lock nuts (left arrow). The right arrow indicates the engagement of the trigger and the sear, which should be altered only by a professional.

means of three lock nuts. It is possible for the knowledgeable amateur to adjust this system by trial and error, but unless you are familiar with this sort of thing it's best left to a professional. In regard to alteration of the engagement of trigger and sear, this is definitely a job for a gunsmith, unless you

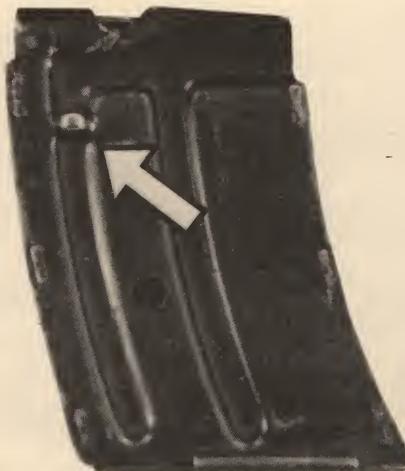
Arrow indicates the catch stud on the magazine, a raised portion of the magazine wall. These will occasionally wear and cause misfeeding.

stock. The catch is its own blade-type spring, but it is not flexed severely, and rarely breaks. An opening in the catch snaps over a protrusion on the right side of the magazine to hold it in place, and the catch protrusion is merely a pushed-out portion of the magazine wall. The sharp edges tend to wear, and the catch will then fail to hold the magazine securely. This can sometimes be repaired by reforming the catch protrusion outward, but if the wear is severe, this may not work. The Model 75 is long out of production (1958), and new replacement magazines and other parts are often difficult to find. The only certain source for magazines is Walter Lodewick, whose address appears in the listing of parts dealers.

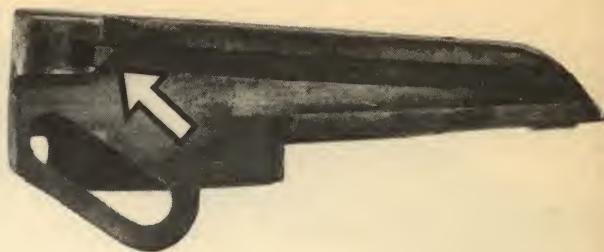
There is another trouble spot which can occur after many years of hard use. The breech block is locked in closed position by a projection on the forward left side of the firing pin which latches into a recess inside the receiver. The locking projection is harder than the receiver wall, and the recess edges will wear in time. It is sometimes possible to tighten the latching by careful peening of the upper edge of the latch recess, but if the wear is serious, it will require spot welding and recutting to restore tightness.

Arrow points to the bolt locking lug, an integral part of the firing pin. These rarely break, but wear in the locking recess inside the receiver can cause looseness.

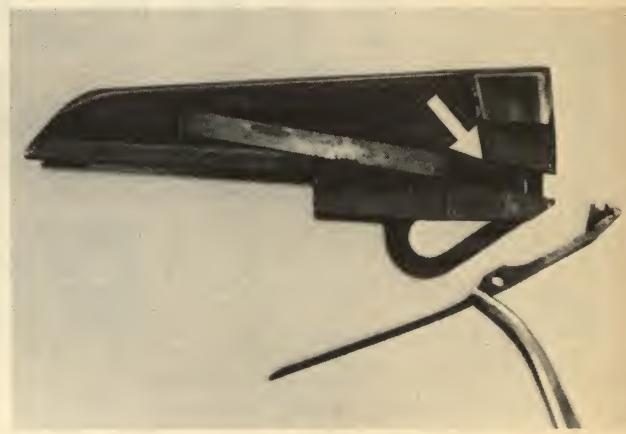
resistance from dirt or a peened chamber edge, the forward portion of the extractor will often snap off. Used replacements can usually be found.

Still in place on the breech block is a broken extractor (arrow). The forceps hold a replacement.

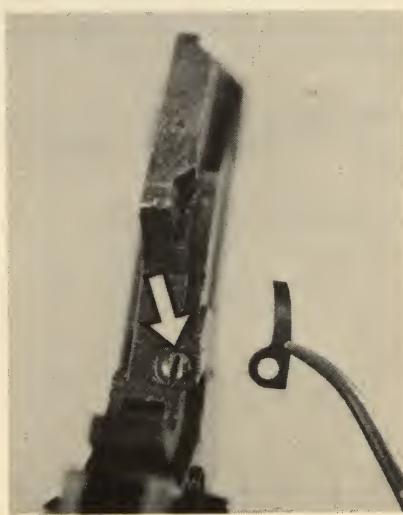
The only thing that could be called a chronic ailment is weakness or breakage of the carrier lever spring. This little curved blade is retained on the right side of the carrier by a small screw and bears on a lever which keeps the carrier positioned during the closing of the breech. The carrier is lifted into position by the opening movement of the breech block, but if the lever spring is weak or broken, the carrier will drop during the closing cycle and cause a misfeed. If a used replacement spring is unavailable, this one, also, can be replaced with round wire.

As mentioned, the carrier lever spring is subject to breakage. The arrow indicates a broken carrier lever spring, still in place, while the forceps hold a replacement.

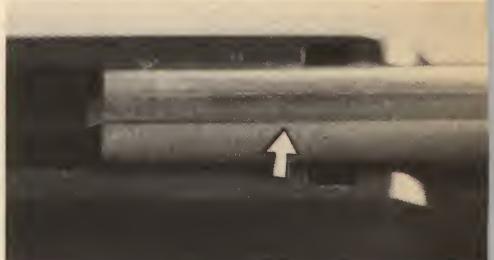
The long extractor of the Model 94 (arrow) is tempered to be its own spring. Breakage is rare, but they occasionally weaken after many years of use.

guns, they do occasionally become a little weak, the beak slipping off the cartridge rim and leaving the fired case in the chamber. When this occurs, it is usually possible to reshape and retemper the extractor. Or, it can simply be replaced, as all parts are readily available.

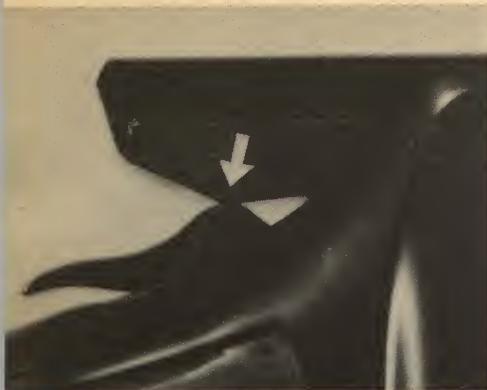
On older guns, extreme wear of breech block or hammer at the point indicated by the arrow will cause cocking failure when the action is cycled.

On older guns, there is often considerable wear at the top of the hammer and on the underside of the breech block at the rear. If the wear is severe enough, the opening of the action will fail to depress the hammer enough for proper sear engagement, and the hammer will fail to cock, following the breech block forward as it closes. There are several ways to correct this, including the installation of a new hammer, or, in extreme cases, a new breech block as well. Adding steel by welding is unwise, as it will affect the factory heat treatment of the parts. I have often repaired this condition by drilling the top of the hammer and force-fitting a slightly tapered hard steel pin, then trimming it off until the hammer is depressed to the proper level.

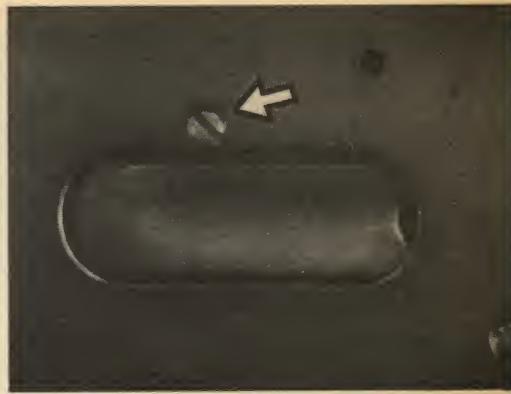
Internal cartridge guides are mounted in the receiver by a single external screw (arrow) on each side. These should be checked occasionally for tightness.

The internal cartridge guides, one on each side, are mounted in the receiver by a single external screw, one for each guide, the one on the right being just above the loading gate. These screws should be checked for tightness every so often, and this same advice applies to the loading gate screw, located to the rear of the loading gate. The tail of the loading gate (into which this screw is threaded) is tempered to be the loading gate spring. Here, again, they seldom break but will often weaken with age. The cures are the same as described in reference to the extractor—either replace the part, or have a gunsmith reshape and retemper the tail to re-

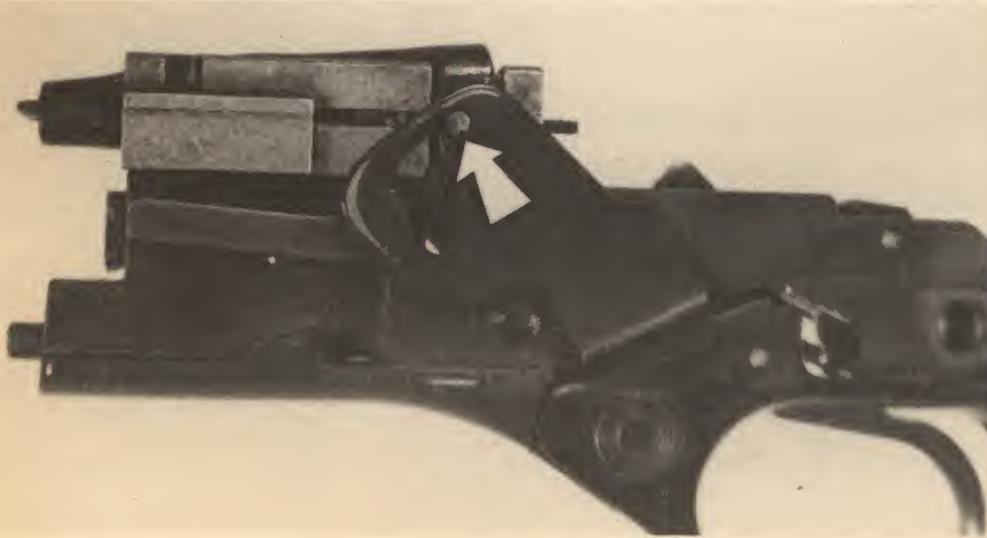
The arrow points to the engagement of the lever arm with the stud on the bolt locking plate. All of the tension of bolt movement and locking is centered on this small pin.

tacts an L-shaped open track in the upper extension of the lever, serving to move the bolt and cam the locking plate upward in the final movement of the lever. The pin is under great strain and is located very near the edge of the arm. In time, it works loose, enlarges its hole in the arm, and deforms the edge. Parts are available, for the time being, and replacement of the locking plate will correct the problem. If no replacement can be found conveniently, a spot of weld can be used to stabilize the pin, after correction of any deformation that may have occurred. Late in the production of this rifle, Winchester redesigned the lockplate, eliminating this problem.

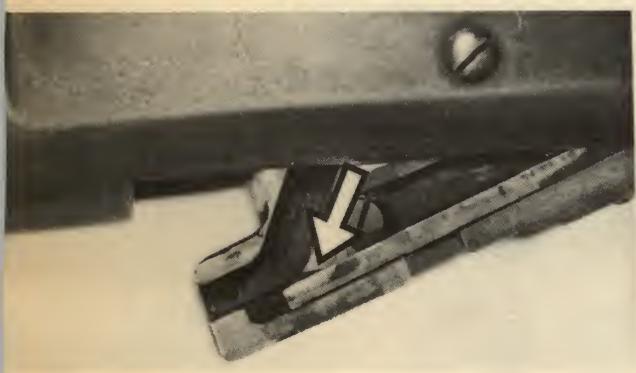
The carrier is locked in place by a laterally-pivoted narrow bar of steel which lies in a recess on the left side of the carrier. If the locking well inside the receiver becomes worn, or the lock bar spring weakens, the carrier, which is also the bolt block, can fail to lock in place when the action is closed. When this condition occurs, amateur gunsmiths will often attempt to cold bend the lock bar outward for better contact without removing it from the carrier. The lock bar is extremely hard, and when this is tried, it will always break. The proper way is to remove the bar from the carrier,

When the slide-lock bar (arrow) or its seat inside the receiver become worn, the gun will fail to lock closed when the action is run forward.

heat it to the right color, and bend it just enough to give improved contact. It should then be rehardened, of course. It's a job for your gunsmith.

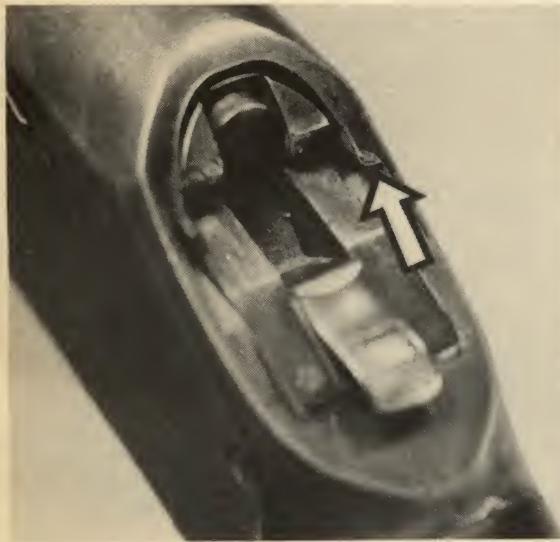
Extreme wear of the upper surface of the bolt guide channels (arrow) can cause the hammer to miss reaching full-cock when the action is cycled.

When a Model 97 is well-worn from years of use, it may fail to cock when the action is cycled, the hammer coming down when the action closes. Usually, this is due to wear of the bolt tracks in the receiver, the bolt tipping upward at its rear limit of travel and failing to depress the hammer enough for sear engagement. This can be corrected in several ways. A very small spot of steel weld on the upper surface of each bolt track in the receiver, recut to fit, will cure it. Or, a hard steel pin installed on each side in the same location works. A less fancy way is to peen the edge of each track, at the rear, inside. In each of these methods, the idea is to lower the bolt and minimize tipping, so that it will depress the hammer enough for engagement of the sear.

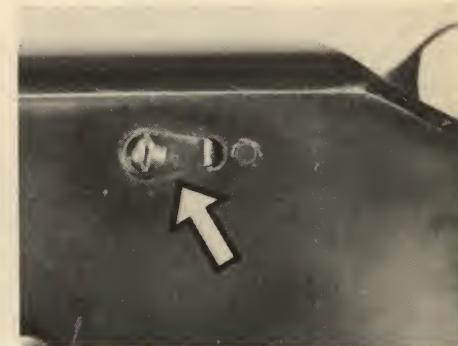
the shell rim each time the action is opened. It is backed up by a solid steel block, but breakage is common enough that it's a good idea to keep an extra one on hand. Two items of good news on this: First, the part has been reproduced in modern times and is readily available; second, the part can be replaced without stripping the gun since the ejector is retained by an external screw, its tip entering a hole in the receiver.

The Model 1897's ejector (arrow) is externally mounted on the left side of the receiver and is easy to replace.

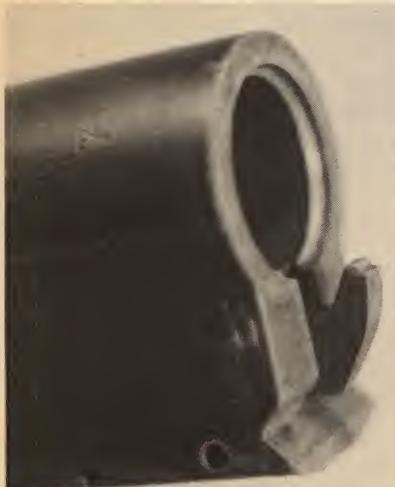
The narrow ejector, an automatic trip-catch type, is prone to breakage.

The Model 37 has an automatic trip-catch type ejector, which snaps out as the action is fully opened to kick the fired shell clear of the chamber. The ejector is quite narrow, made from flat stock, and is deeply cut near its forward end for the beak of the ejector sear. At this point, it often breaks. The factory may still have some parts for the Model 37, but I can tell you one certain thing—they have no ejectors in 12, 20, or .410 gauge. If a replacement can't be found among the used-parts dealers, the only alternatives are to repair the broken ejector by welding, or have a gunsmith make a replacement. Here, again, in the design of the Models 370 and 37A, the ejector is of a much more sturdy pattern.

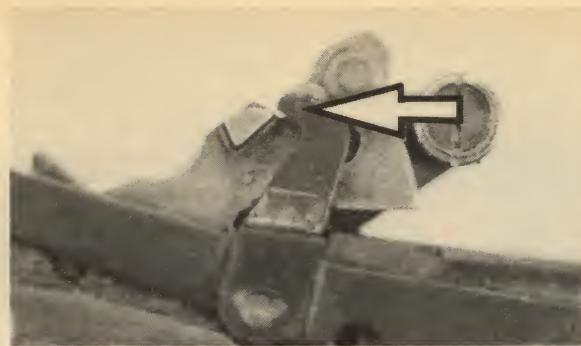
With long use, there may be wear on the disconnector arm of the slide lock at its contact point with the hammer (arrow). Repair of this condition should be left to the gunsmith.

With long use, there may be wear of the disconnector arm of the slide lock at its contact point with the lug on the hammer. It is often possible for a gunsmith to recut the beak of the arm to correct this, but in extreme cases the entire slide lock must be replaced. A badly worn beak can be built up with weld, but this necessitates removal of the two springs mentioned earlier, to prevent damage from the welding heat.

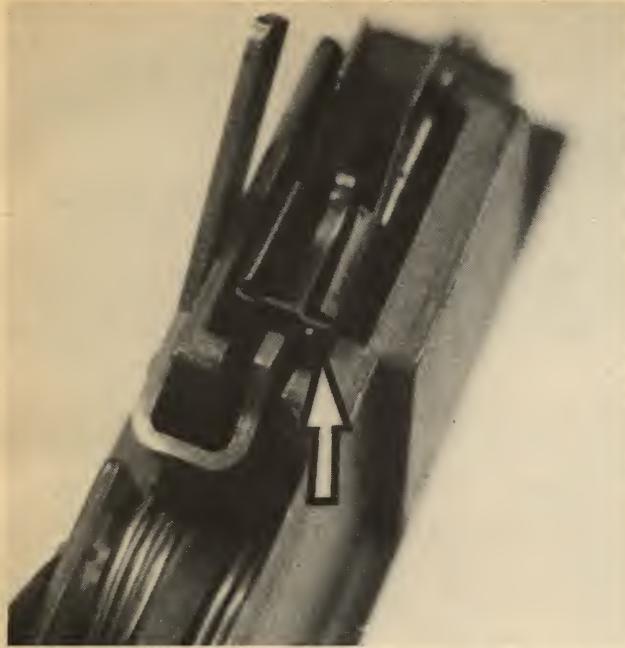
The cartridge guide, which holds the round picked up from the magazine in position for feeding into the chamber, is of rather lightweight formed steel. In normal use, it will usually cause no difficulty. With any improper disassembly or reassembly,

or other tampering, however, it is easily deformed. If the cartridge guide does become deformed, it can often be straightened, or easily replaced.

**CAUTION:** Don't tamper with the cartridge guide (arrow). It's made of rather lightweight formed steel and will, if abused, become deformed.
